NATIONAL ADVISORY COMMITTEE FOR AERONAUTICS

No. 1573

FLIGHT MEASUREMENTS OF THE FLYING QUALITIES OF
FIVE LIGHT AIRPLANES

By Paul A. Hunter

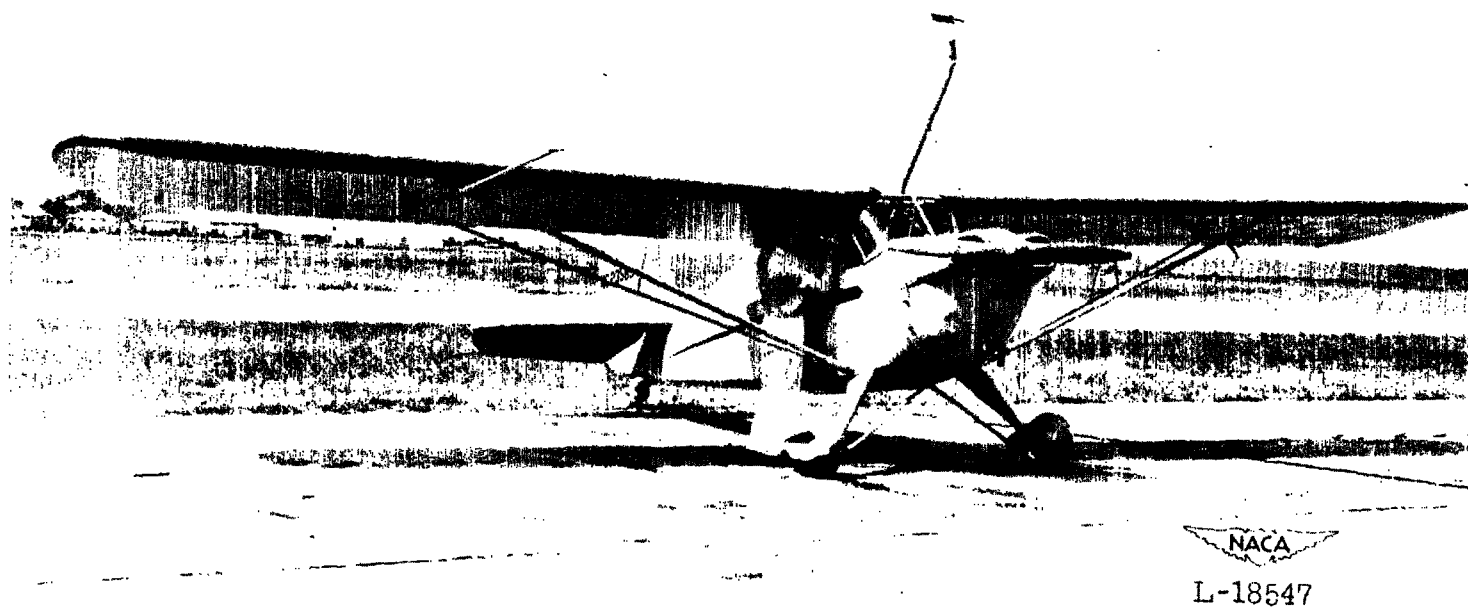
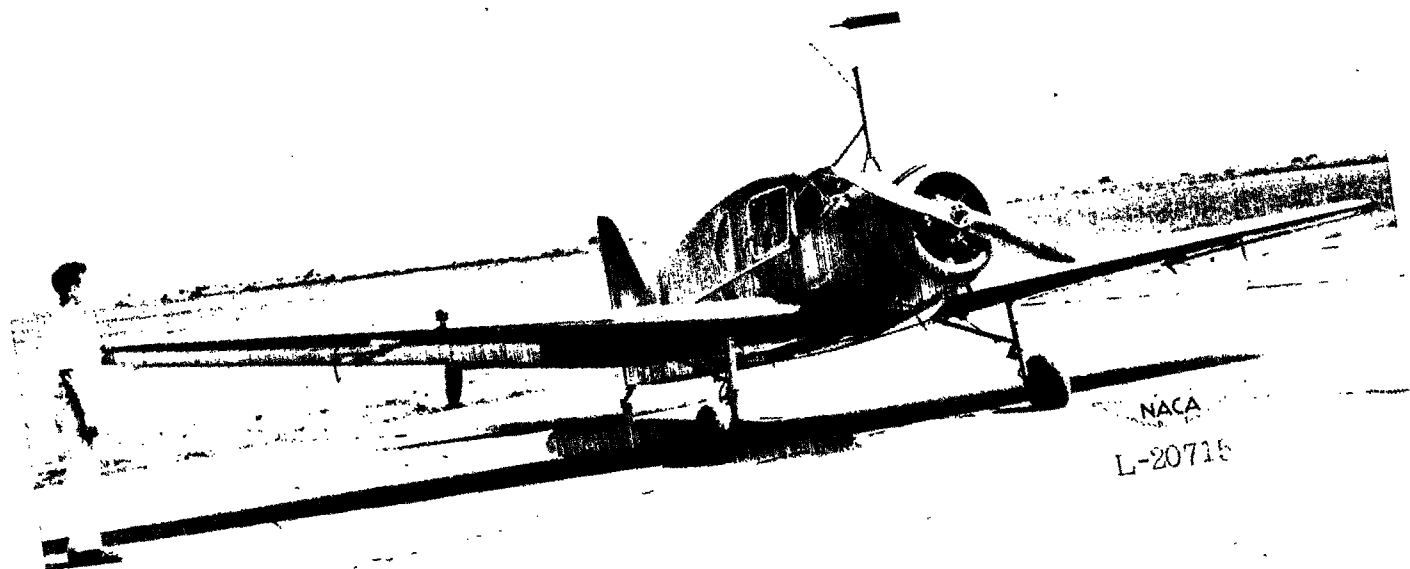
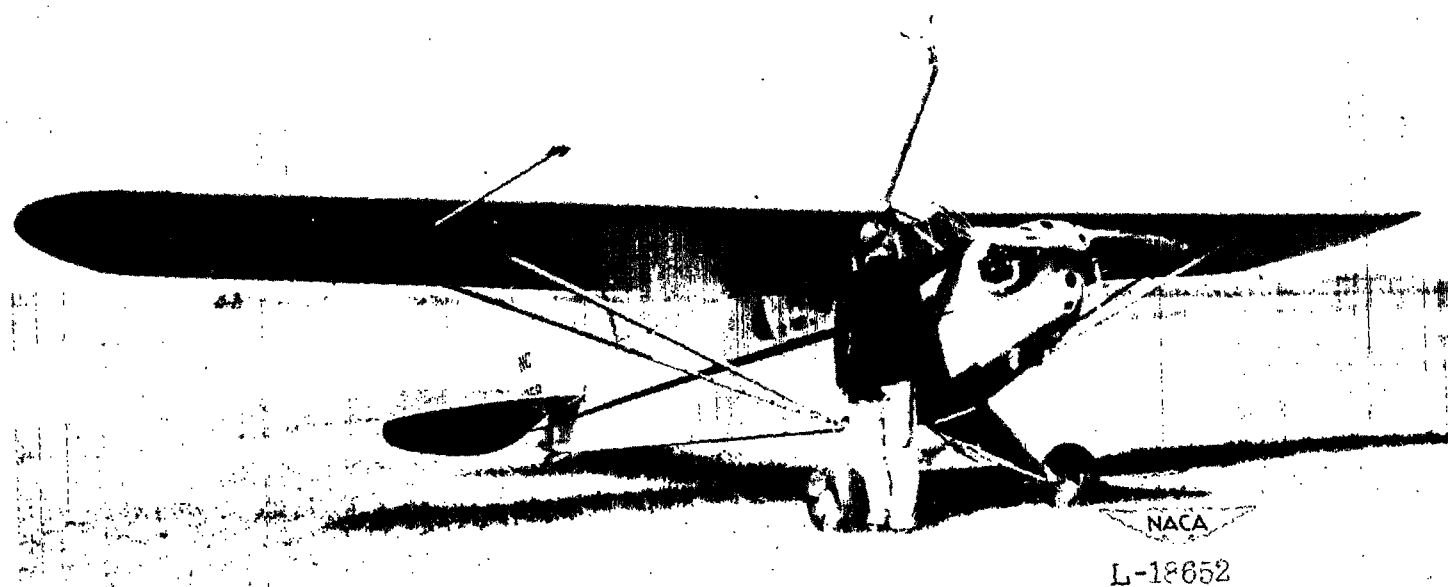
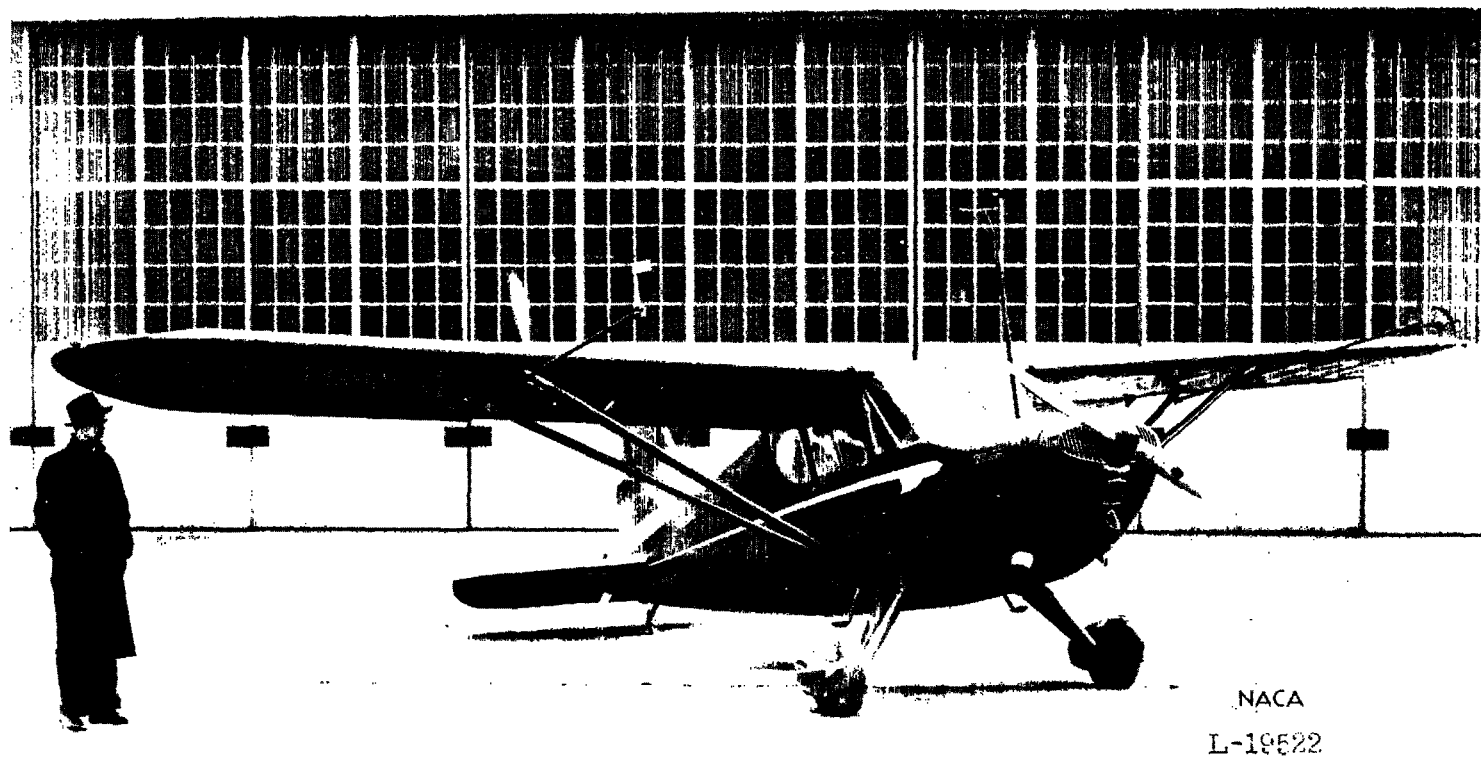
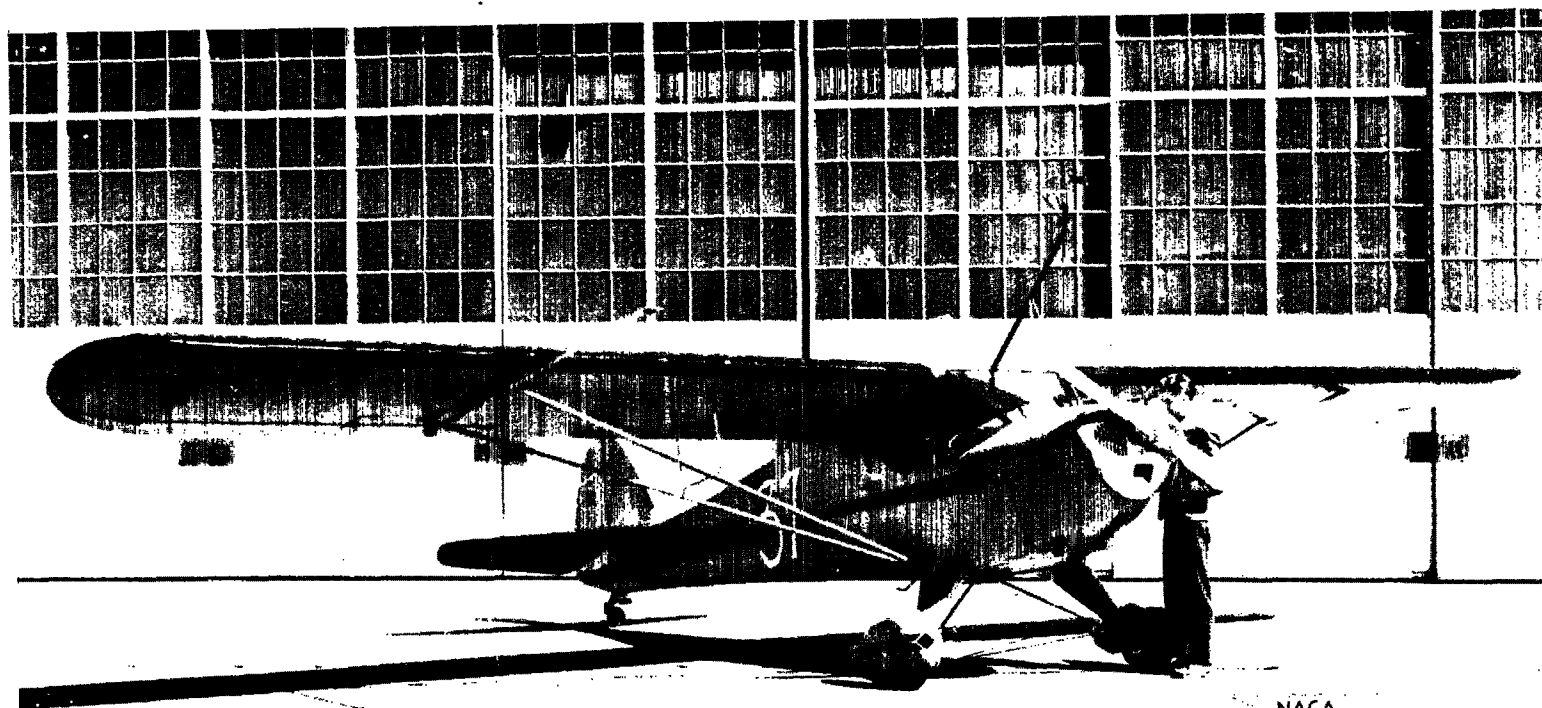
Figure 1.- Three-quarter front views of airplanes tested.

Descriptive characteristics of the five light airplanes are given in table I. Photographs of the five light airplanes are shown as figure 1 and three-view drawings are shown in figure 2. All five airplanes were two-place or three-place cabin land monoplanes and, except for airplane 2, all had fixed landing gears. Airplane 4 was the only one that had wing flaps and/or slots. The control-surface gaps were unsealed, except in the case of the rudder and elevator of airplane 2. The longitudinal trimming device consisted of an elevator trim tab for airplanes 1, 2, and 4; an adjustable stabilizer for airplane 3; and an independent airfoil mounted below the horizontal tail for airplane 5.

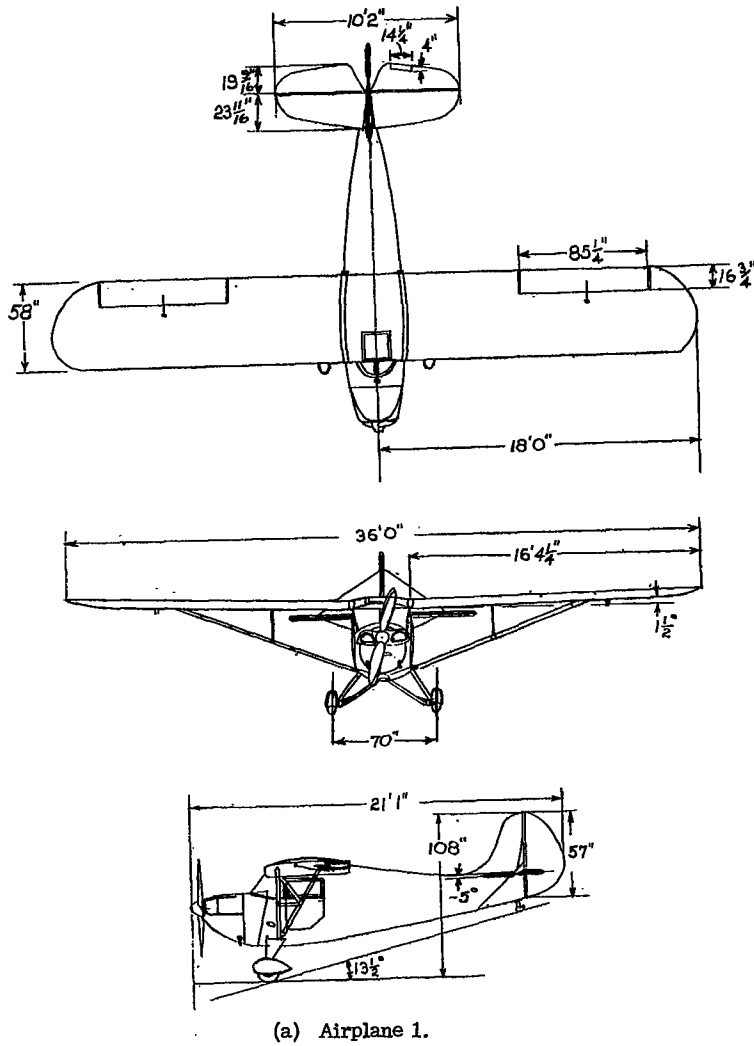
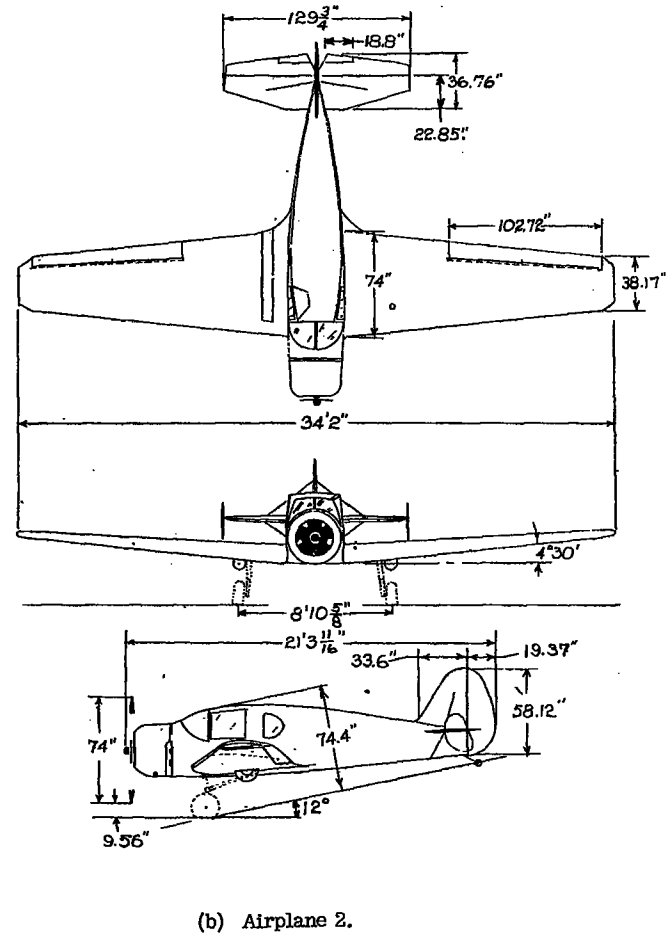
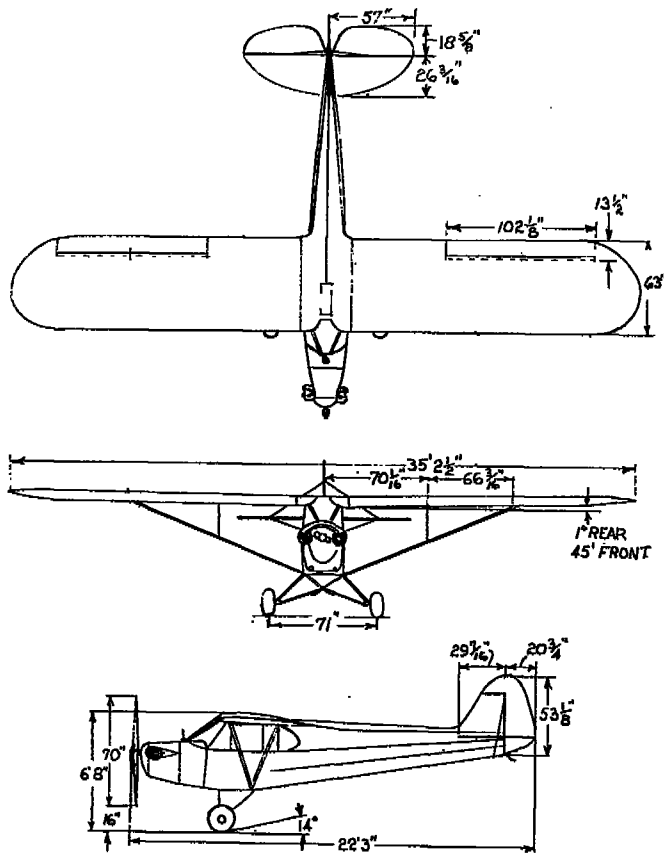
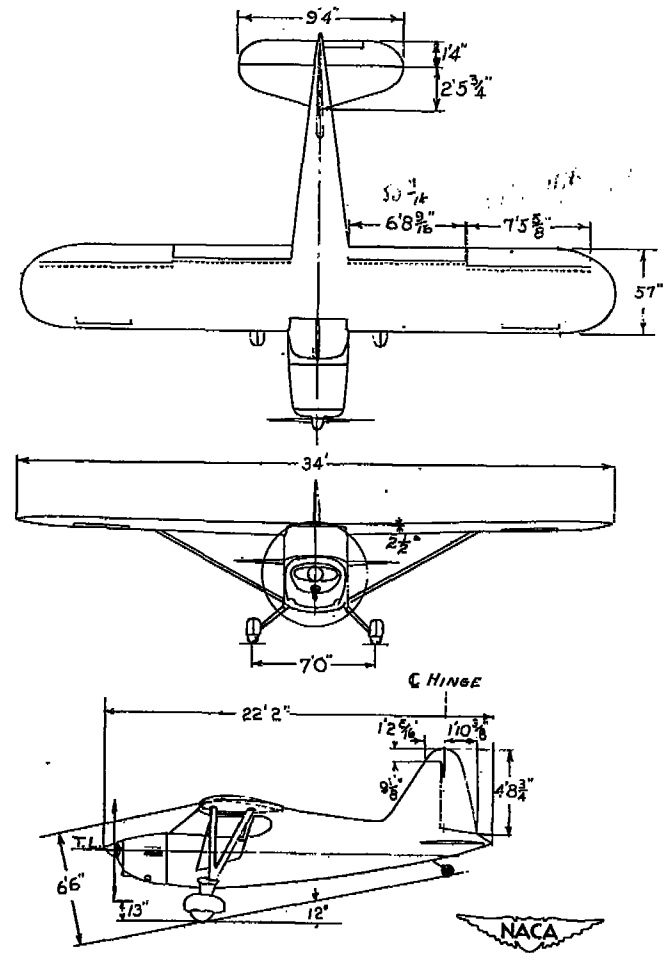
Figure 2.- Three-view drawings of airplanes.

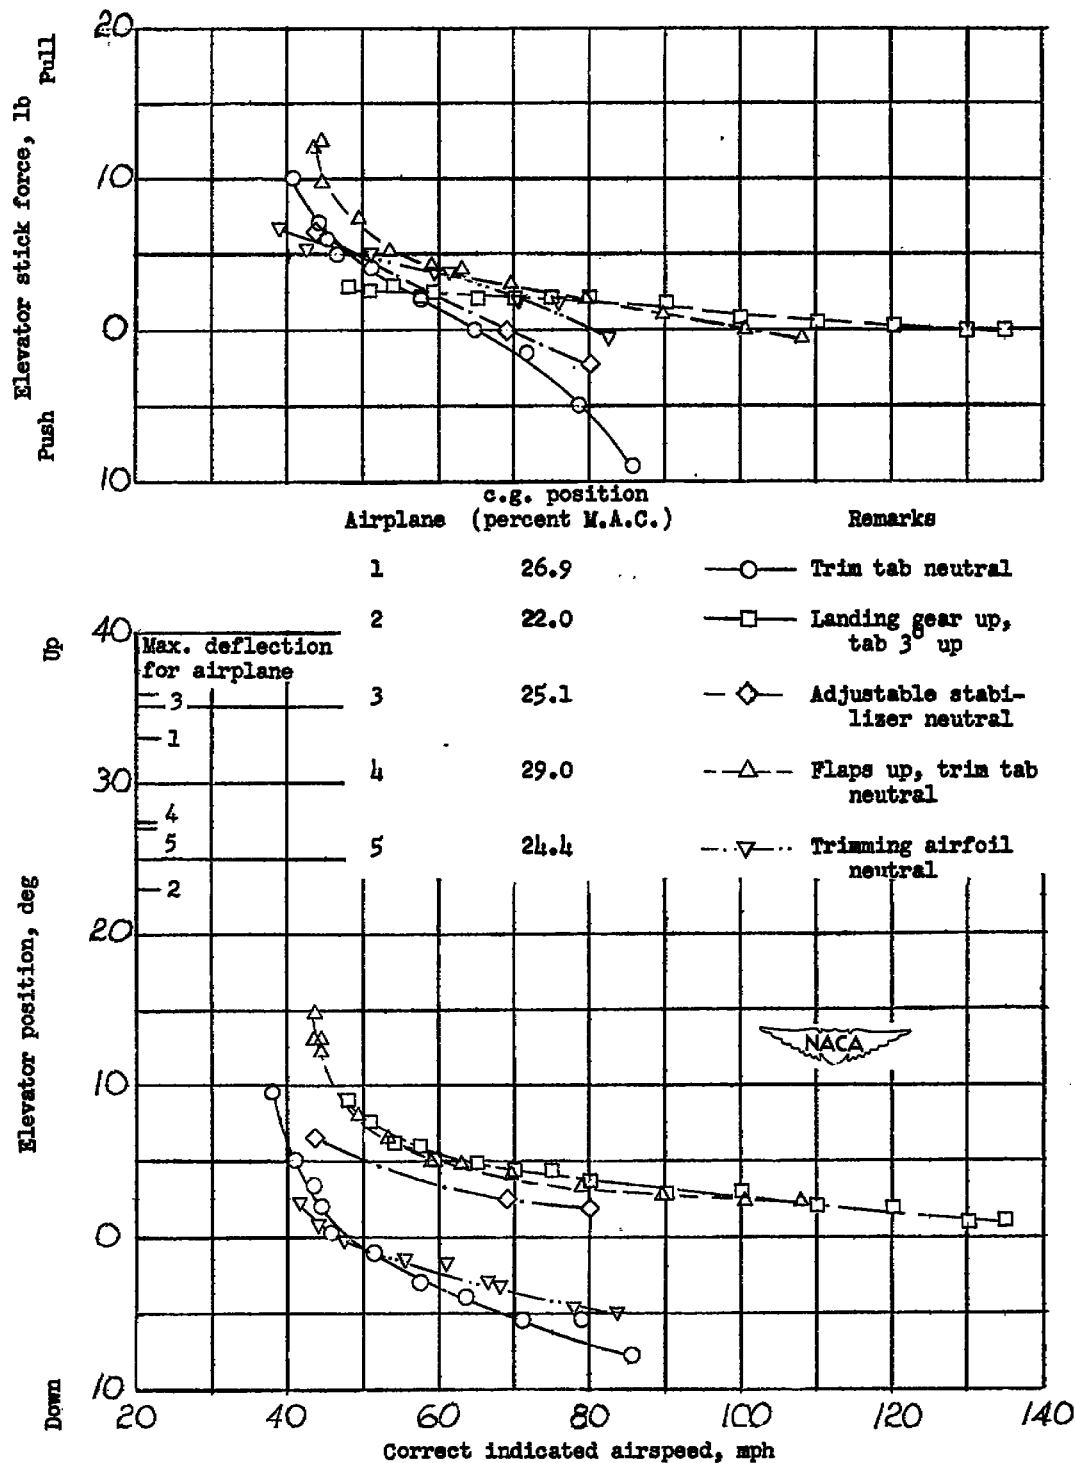
Figure 3.- Static longitudinal stability characteristics. Power-on cruising; airplanes 1, 2, 3, 4, and 5.

Static longitudinal stability.— The static longitudinal stability characteristics of the five light airplanes for the power-on cruising condition at a center-of-gravity position in the middle of the allowable range are shown in figure 3. The trim devices were set at neutral for four of the five airplanes. No data on airplane 2 with tab neutral were available; therefore data with the airplane trimmed full nose heavy (tab 3° up) were used. It is not believed that this tab deflection would cause much variation in elevator angle and stick force from those with neutral tab position. This condition was chosen because it is the one in which the most flying time is spent and is the one for which the most comparable data were available. The variation of elevator angle with airspeed, shown in the lower part of figure 3, is an indication of the so-called stick-fixed static longitudinal stability and provides an indication of the stability in terms of the pilot's feel of stick position. Positive stick-fixed stability insures that the airplane will tend to return to a given angle of attack or airspeed following a disturbance. The five light airplanes tested were statically stable, longitudinally, with stick fixed and power on, as shown by the negative slope of the curve of elevator position against airspeed, although the degree of stability varied

The stick-free static longitudinal stability characteristics in the power-on cruising condition are shown by the curves of elevator stick force plotted against airspeed in the upper part of figure 3. The variation of elevator stick force with airspeed is an important criterion of the pilot's control "feel." The curves show that all five airplanes were statically stable, longitudinally, with stick free and power on and that the forces were small compared to the pilot's physical capabilities.

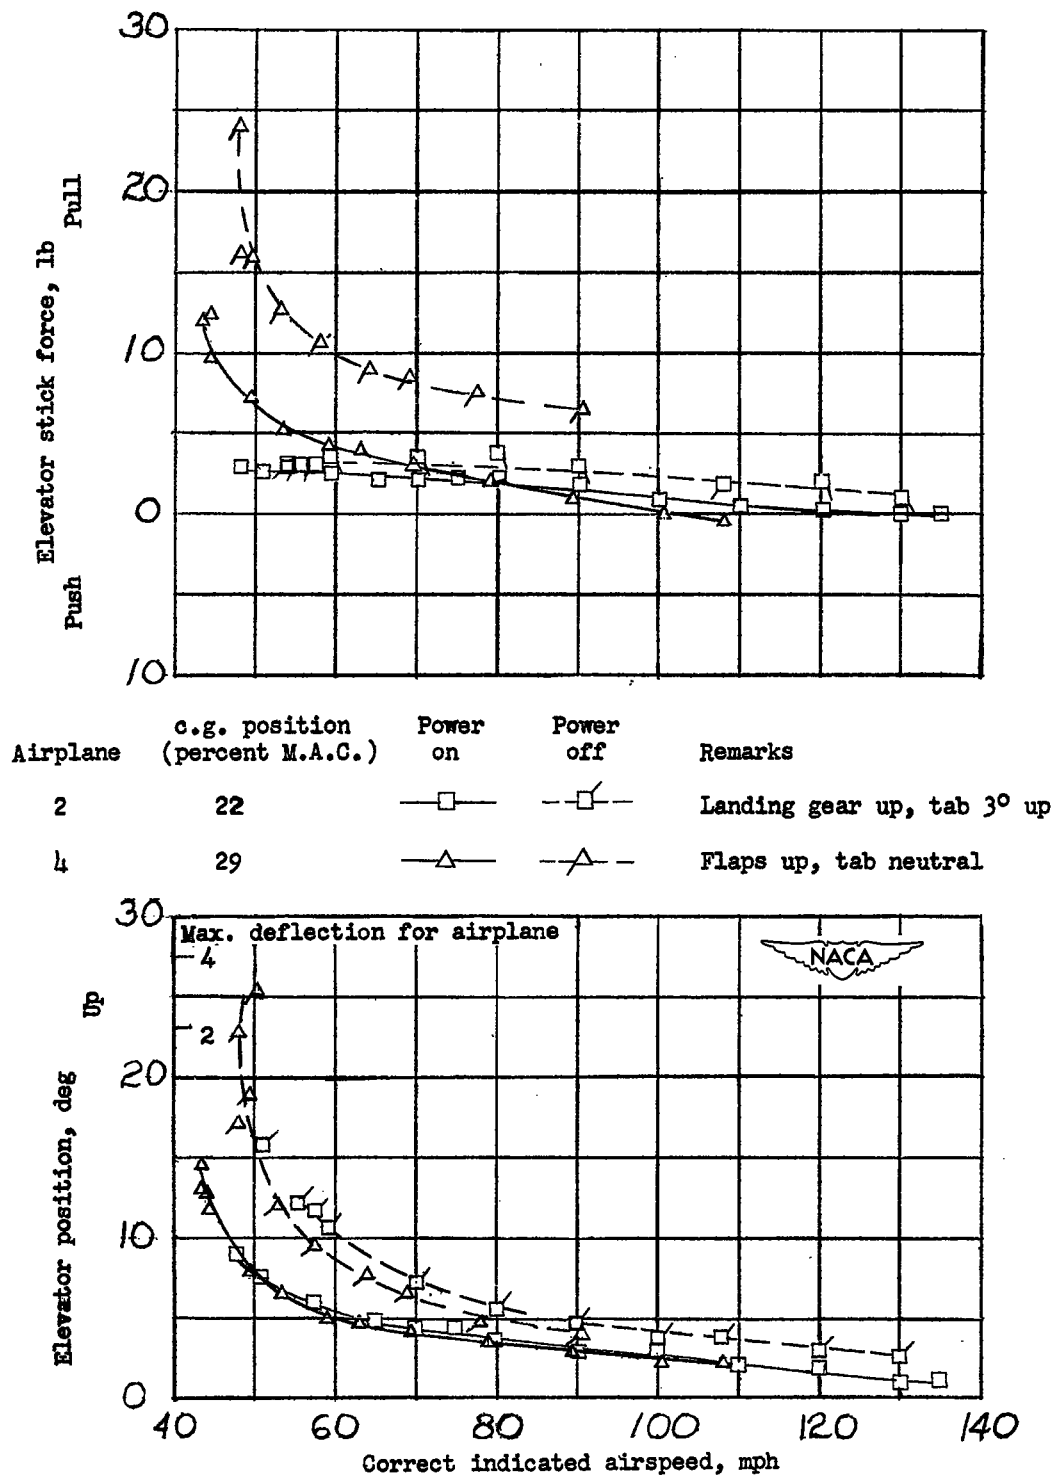
Figure 4.- Effect of engine power on static longitudinal stability characteristics. Airplanes 2 and 4.

the steeper slope of the curve of elevator angle against airspeed. This effect was the same for all five airplanes tested. The increased pull forces required to trim at a given airspeed with power off may be seen from the curves of figure 4 for both airplanes although the force changes are greater for airplane 4. Had the airplanes been trimmed at the same airspeed for the power-off condition as for the power-on condition, the slopes of the power-off curves would have been increased and would indicate an increase in stick-free static longitudinal stability.

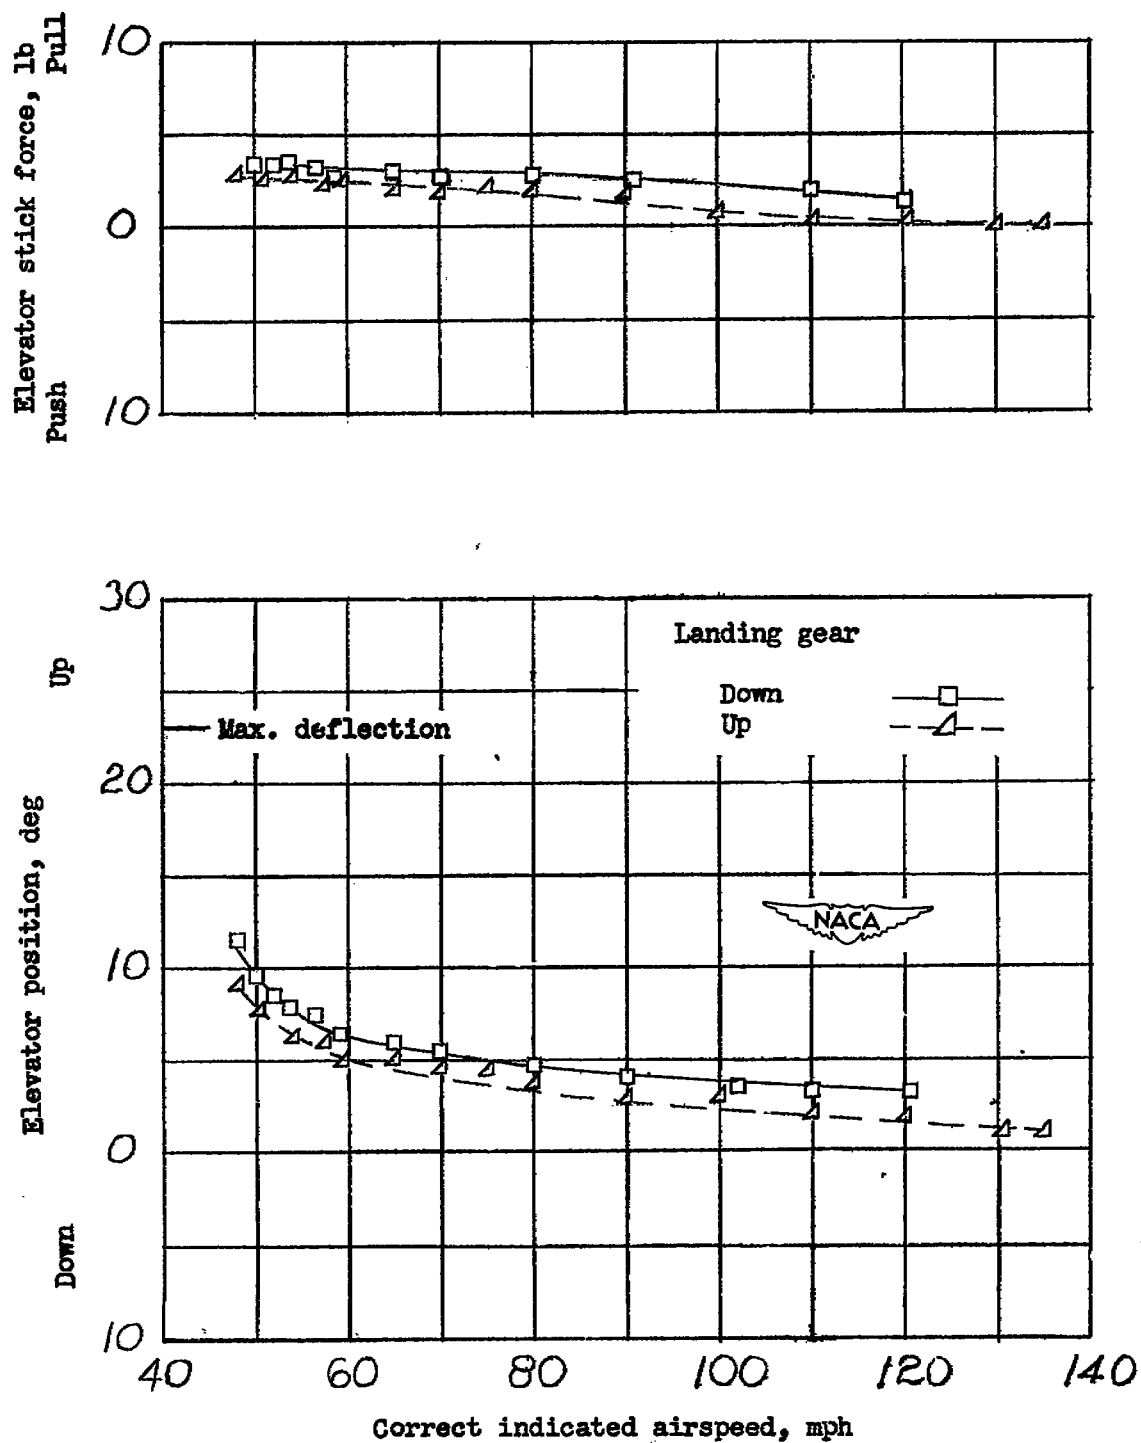
Figure 5.- Effect of landing gear on static longitudinal stability characteristics. Center-of-gravity position, 22 percent M.A.C.; trim tab 3° up; power on; airplane 2.

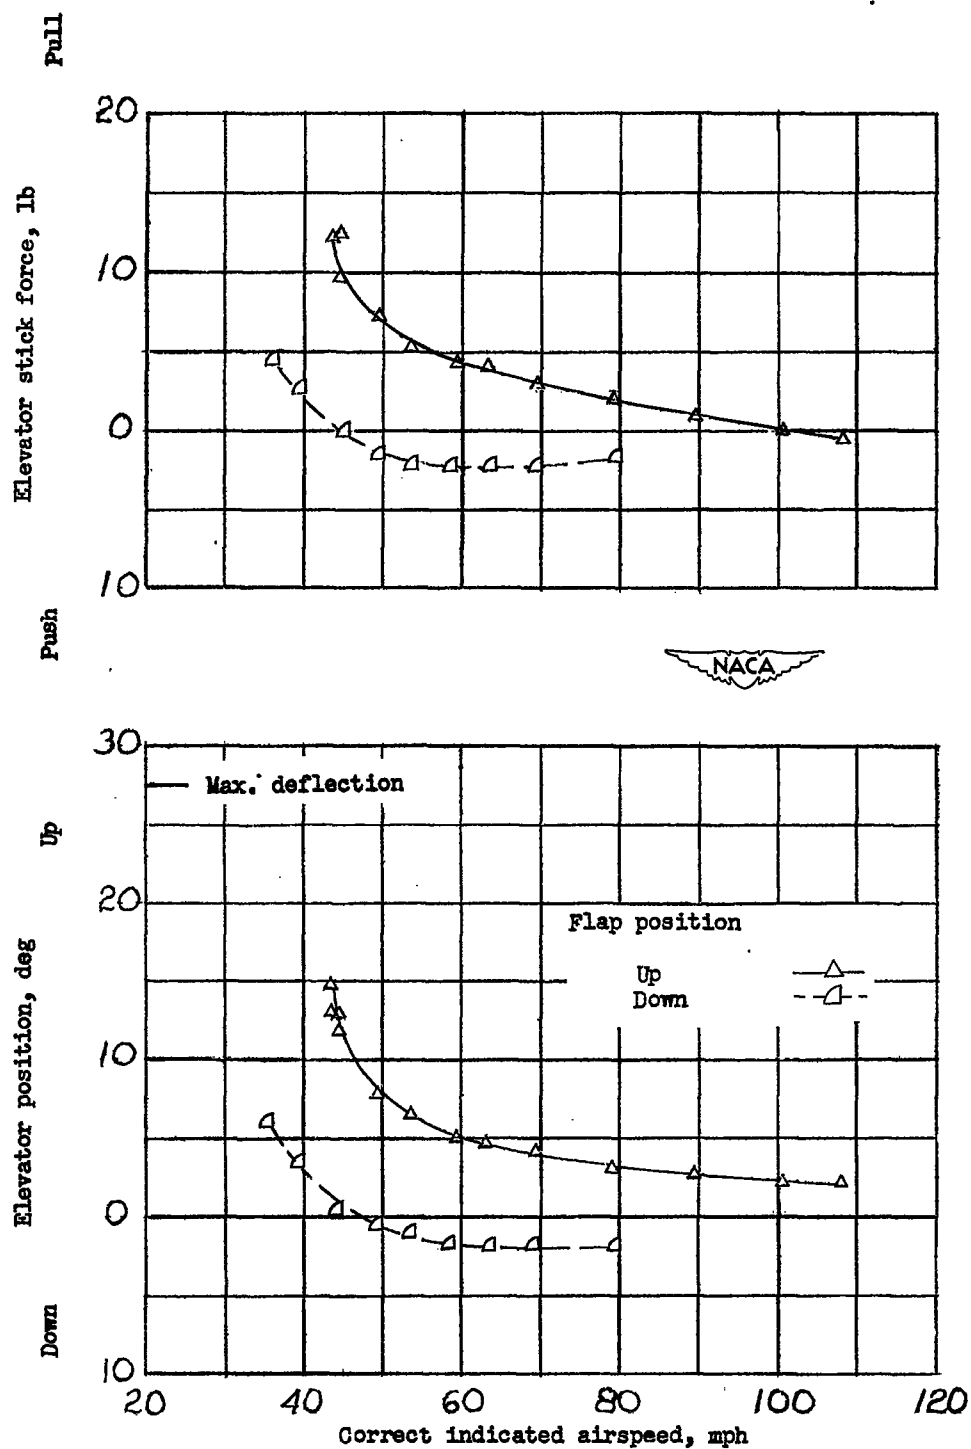
Figure 6.- Effect of flaps on static longitudinal stability characteristics with power on. Center-of-gravity position, 29 percent M.A.C.; trim tab neutral; airplane 4.

The effect of flaps on the static longitudinal stability of airplane 4 is shown in figure 6. Deflecting the flaps caused a decrease in stability, both stick-fixed and stick-free, and also reduced the up-elevator angles and pull forces required to trim at various airspeeds throughout the speed range. These effects were probably caused by a change in downwash over the horizontal tail and/or a change in dynamic pressure at the tail with flaps down. Notice the slight stick-free instability and stick-fixed neutral stability which occurs in the power-on flaps-down condition at speeds above 60 miles per hour. This condition was the only one in which negative stability was found to exist for any of the airplanes tested.

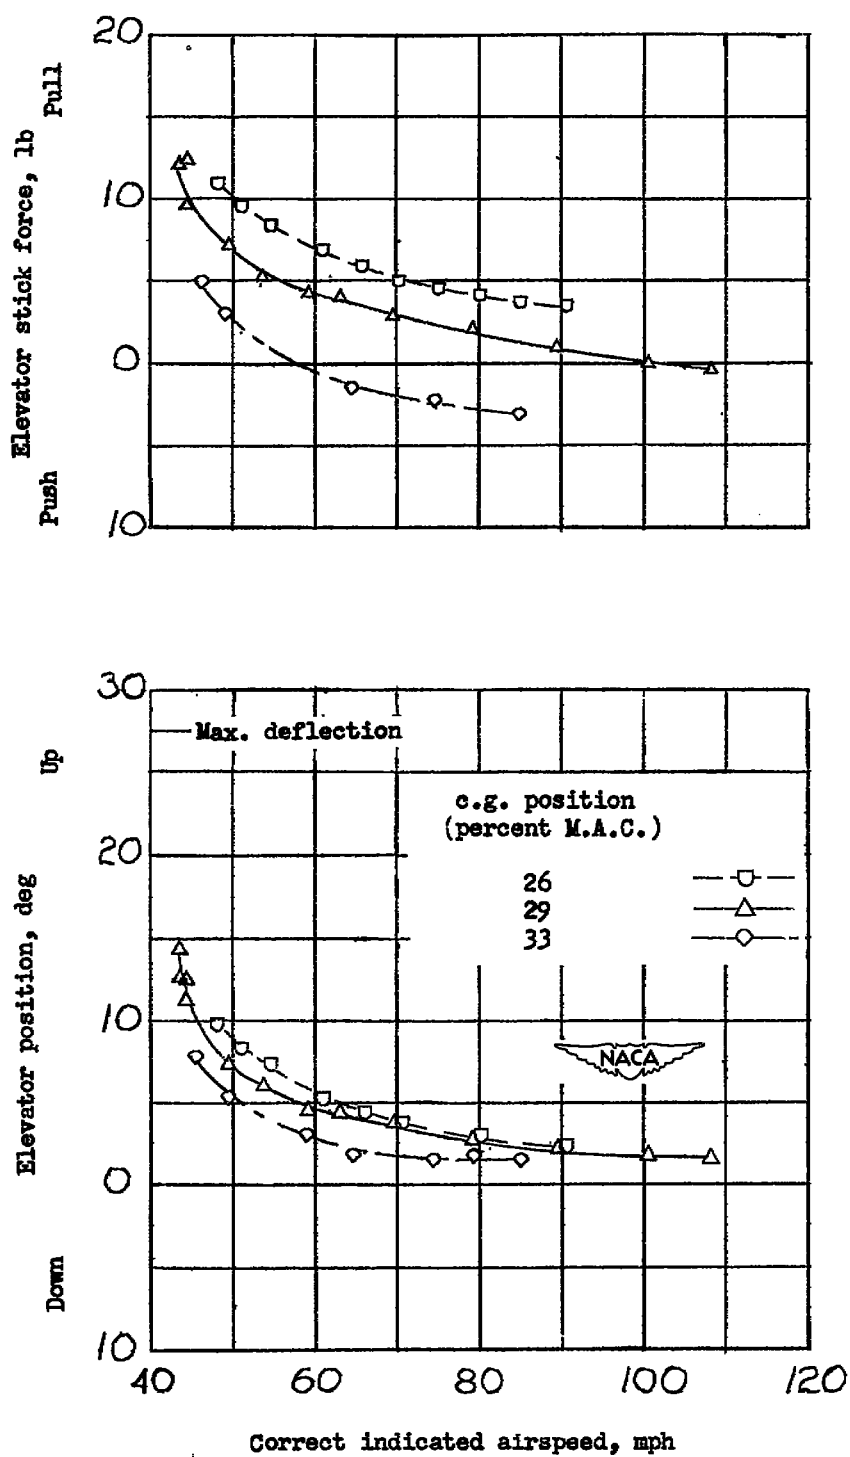
Figure 7.- Effect of center-of-gravity position on static longitudinal stability. Trim tab neutral; power on; flaps up; airplane 4.

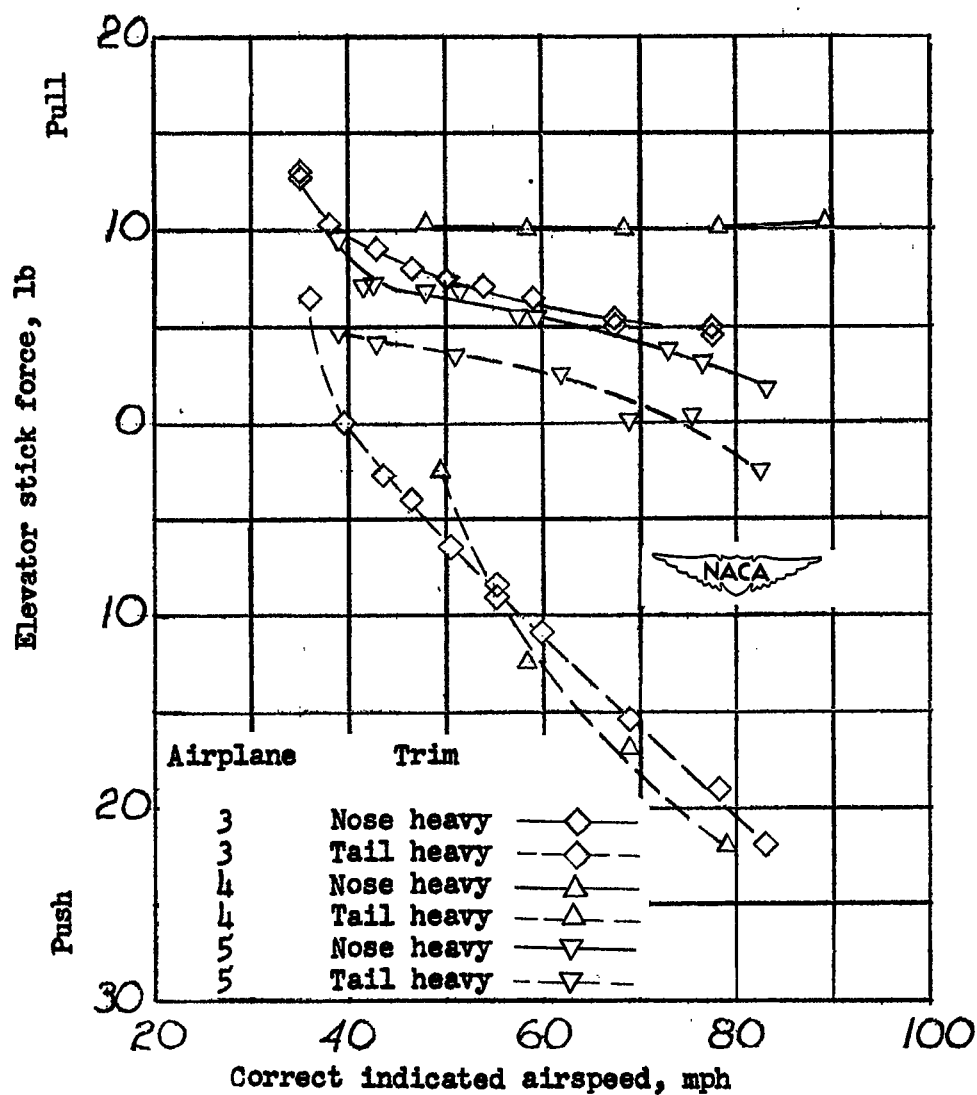
Figure 8.- Effect of trim-device setting on the variation of elevator stick force with speed. Power on; airplanes 3, 4, and 5.

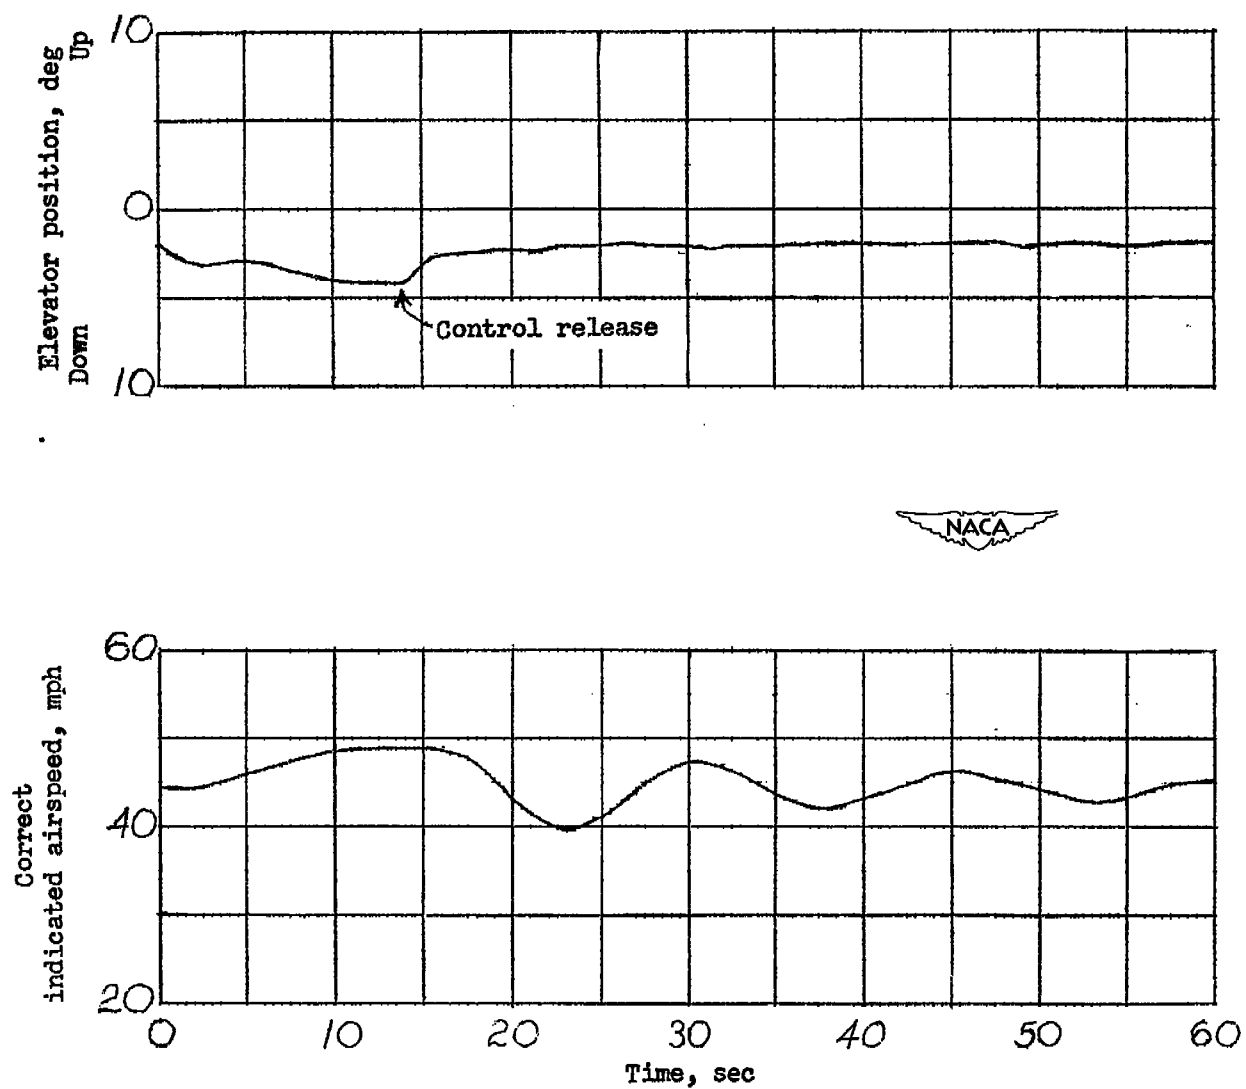
Figure 9.- Time history of a typical longitudinal oscillation. Flaps up; power on; rearward center-of-gravity position; airplane 4.

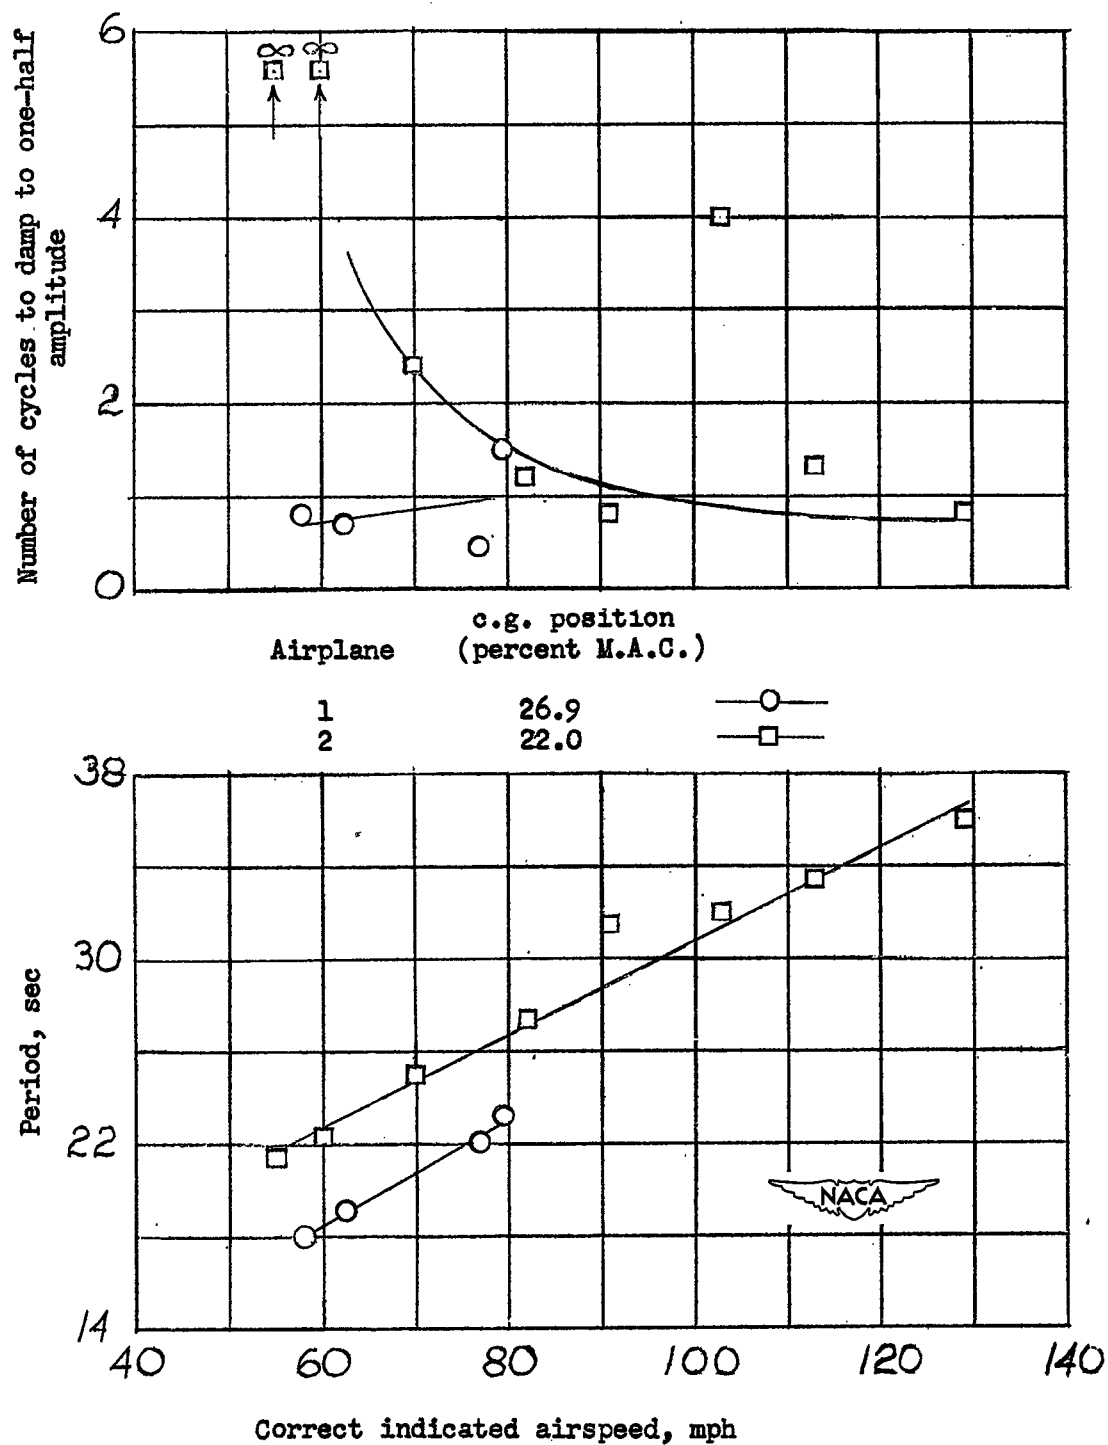
Figure 10.- Period and damping characteristics of longitudinal oscillations. Power on; airplanes 1 and 2.

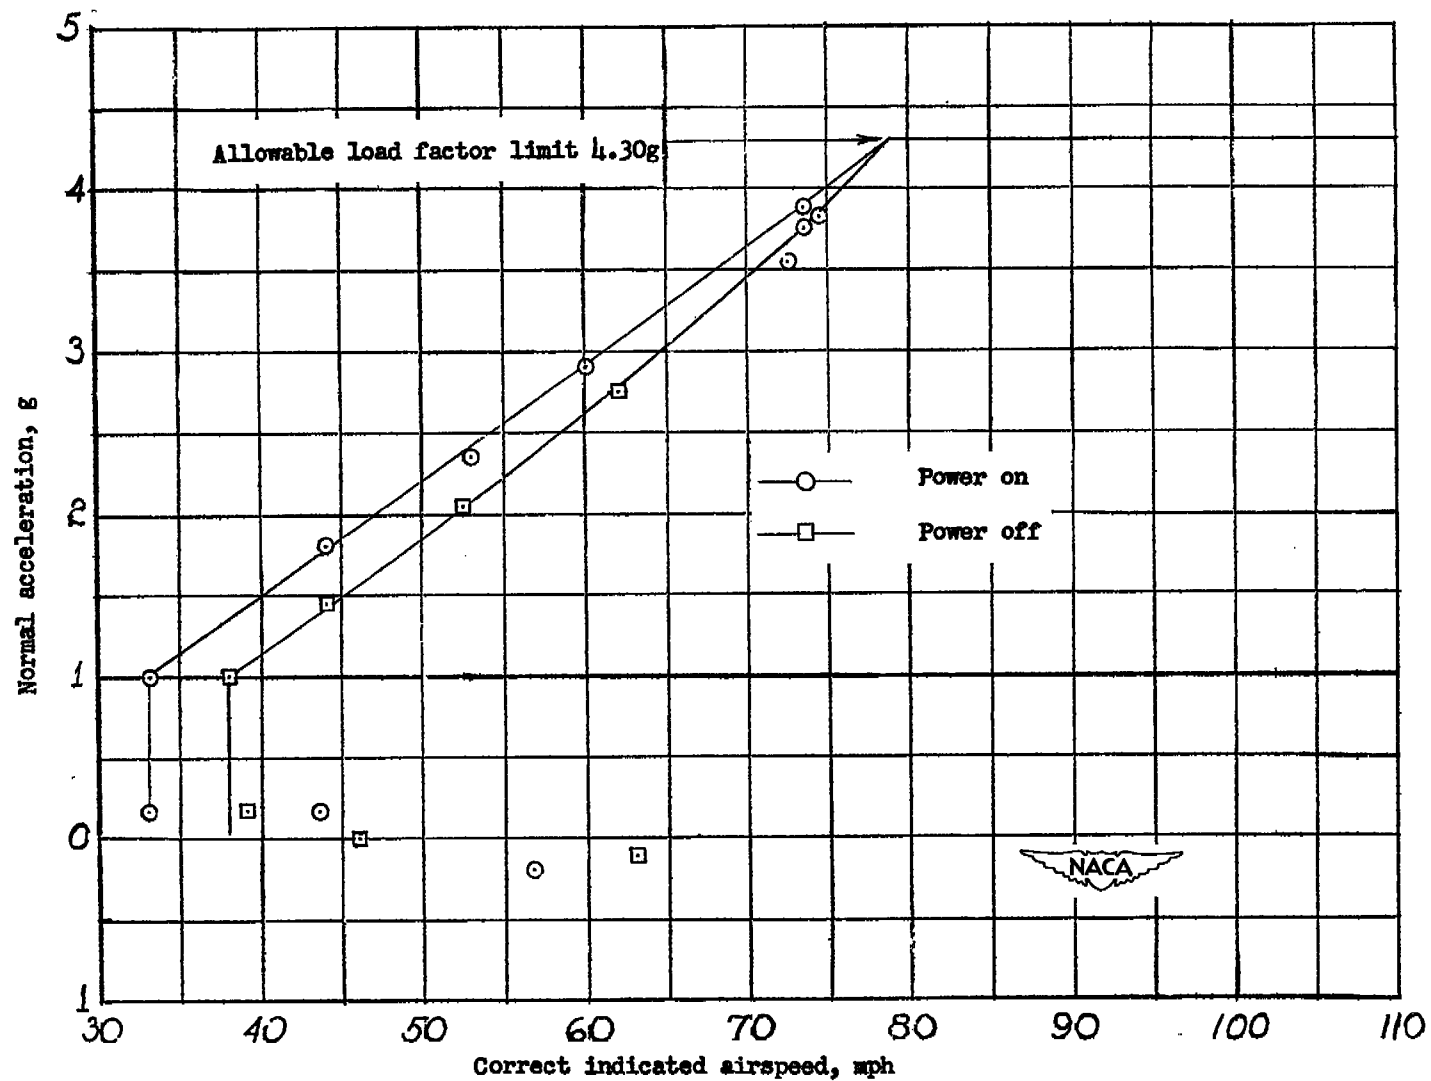
Figure 11.- Normal accelerations produced by abrupt pull-ups and push-downs from level flight with power on and off using full elevator control. Airplane 3.

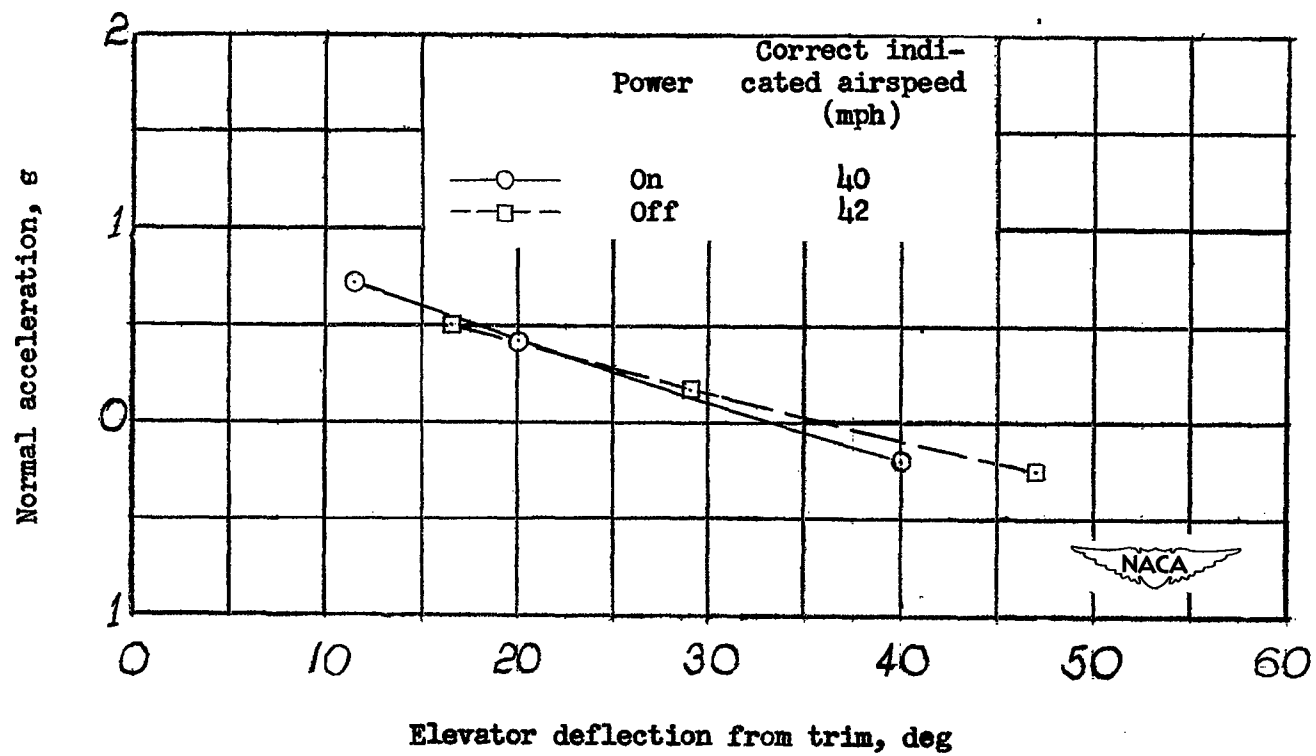
Figure 12.- Normal accelerations produced in abrupt push-downs at speeds close to stall.
Airplane 1.
